**BIG LIFT LLC** LIFT TRUCK SALES AND SERVICE

## Service Bulletins

| Quick Tip Bulletin | Date: | March 3, 2012 | Bulletin Number: | QT - 001 |

| Model: | E30 – EZ30 | Description: | Troubleshooting Intermittent Shutdown |

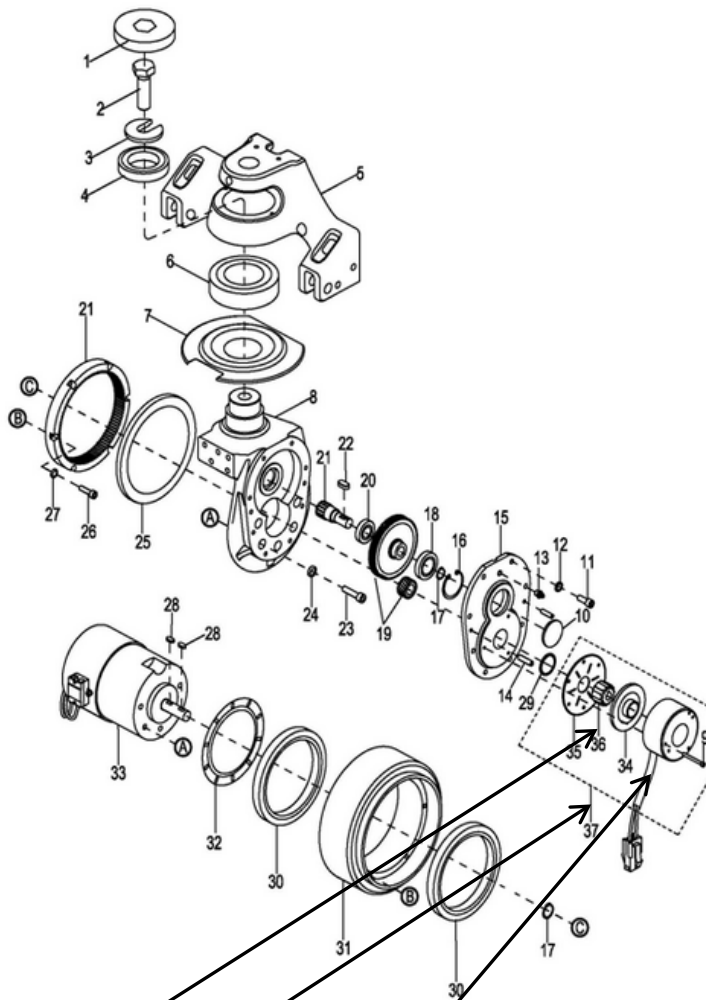
E30 >> TRANSMISSION, MOTOR AND BRAKE MOUNTING >> TRANSMISSION, MOTOR AND BRAKE MOUNTING

Three (3) mounting screws holding the Brake Assembly to the motor may loosen during operation. This could cause the E30 pallet jack to shut down.

If any combination of the mounting screws loosens, the brake assembly will shift at a slight angle causing the brake to drag. As the brake heats up a message is sent to the controller of the overheating and will shut down the pallet jack. Once the brake assembly cools, the controller senses the temperature change and will allow the pallet jack to operate until it senses the brake assembly overheating and will shut down the pallet jack. If your customer calls with this type of complaint, follow the Corrective Action below.

Brake Assembly – Item 34

Brake Assembly Mounting Screws – Item 38

- 1). Disconnect electric brake from harness. (Item – 34)
- 2). If mounting screws are loose, align brake assembly to proper position and snug mounting screws. (do not fully tighten at this time Item - 38)
- 3). Remove one (1) mounting screw at a time and coat threads with **(Loctite® Threadlocker Blue 242® recommended in the event the Brake Assembly may need replacement in the future)**. Once all screws have been coated with Loctite® and reinstalled, tighten in a star pattern making sure there is equal pressure on all points of the brake to the plate. (Item – 38)

- 4). Reconnect electric brake to harness.
- 5). Return drive wheel to floor and unblock load wheels.
- 6). Check operation.
- 7). Reinstall lower compartment covers.

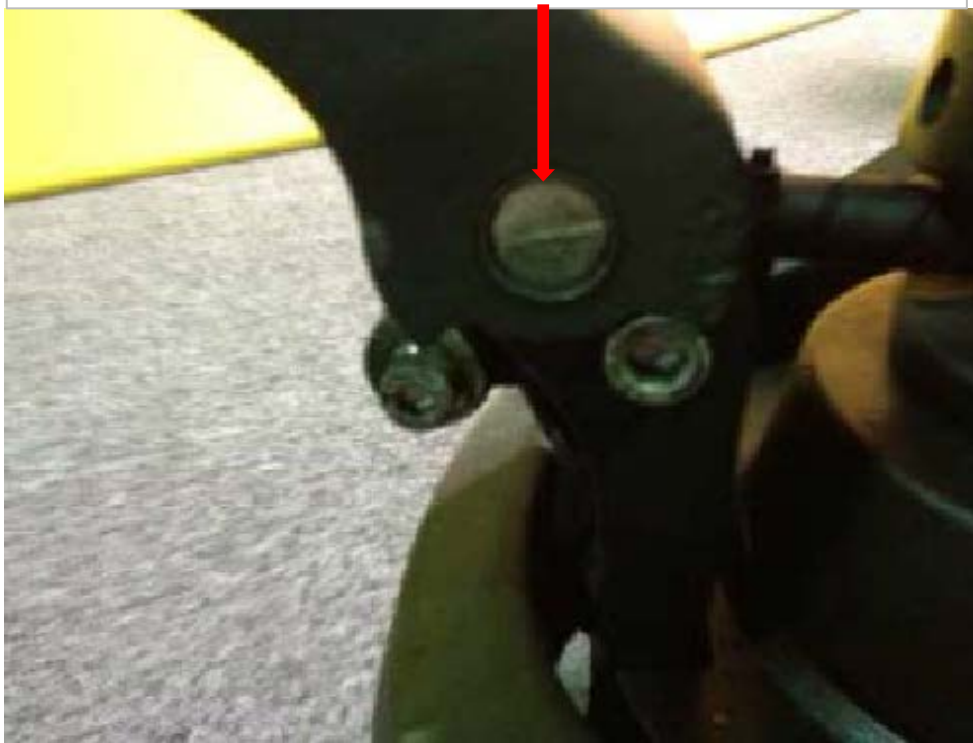
When conducting a Scheduled PM, ensure the Handle Arm Set Screw is tight in the Joint Bracket. If the set screw backs out and loses contact with the Handle Arm Pivot Detent, the Handle Pivot Pin will start to work its way out and cause play in the Handle Arm.

Handle arm set screw backs out of detent on the handle pivot pin due to the lack of Threadlocker® on the set screw threads prior to installation.

**Picture of handle pivot pin correctly installed so handle set screw will seat in handle pivot pin detent. Scribe a line or use a paint pen to mark both sides of the Pivot Pin location.**

Handle Pivot Pin Must Be In The Horizontal Position As Shown Below

1). Remove handle arm set screw (item #6) and inspect threads for damage. If threads are damaged replace with part number 0000-000016-00.

- 2). Before installing set screw, verify the handle pivot pin detent is visible through the tapped set screw flange. The handle pivot pin (item #9) must be in a horizontal position for the set screw to seat properly.
- 3). To adjust the handle pivot pin insert Large #3 Screw Driver in pivot pin slot and adjust until you can see handle pivot pin detent. (see picture)
- 4). Coat set screw threads with LOCTITE® THREADLOCKER BLUE 242® or equivalent.
- 5). Install handle set screw and tighten.

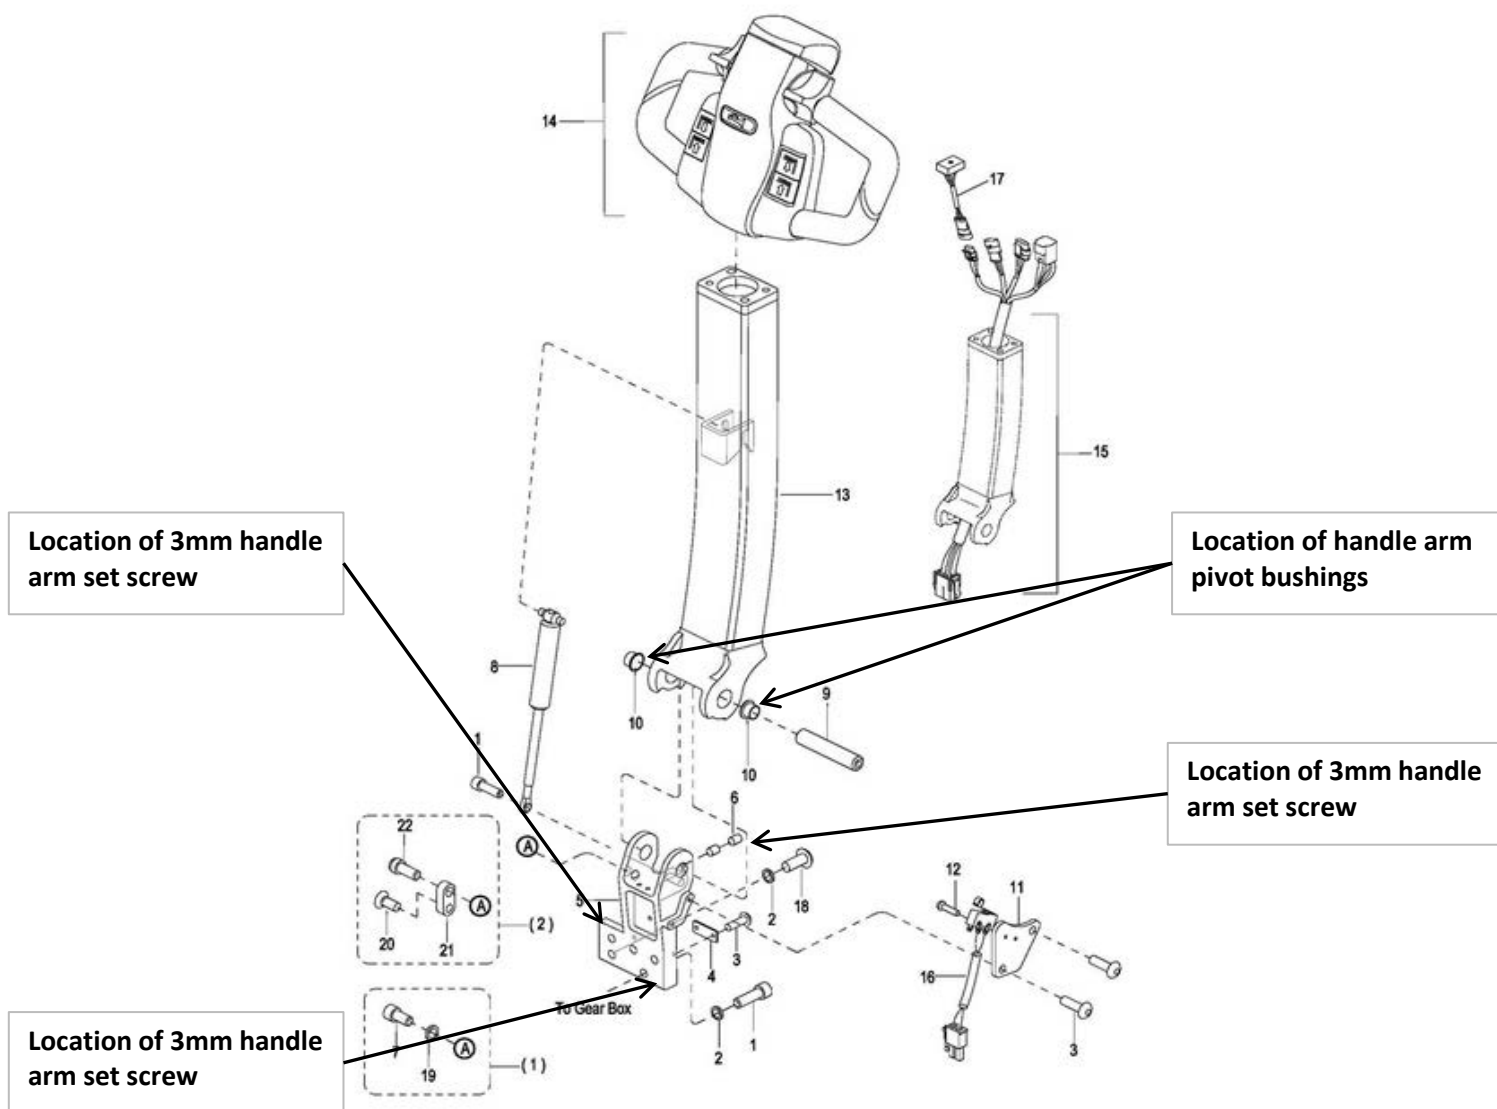
E30 >> STEERING ARM >> STEERING ARM

When conducting a scheduled PM, check to ensure the Joint Bracket Screws are tight. If the allen head screws are loose it could cause excessive wear on the Handle Pivot Pin Bushings.

The joint bracket which is secured to the gear box by three 6mm allen head cap screws (item 1) and two 5mm allen head cap screws (item 5 may back out of the gear box due to lack of Threadlocker® on the cap screws prior to installation).

1. From the back of the unit remove the upper cover. (It is not necessary to remove the motor and control covers,
2. Check to see if the three 6mm and two 5mm joint bracket bolts have backed out. If they are tight and have not backed out reinstall the upper cover, if bolts have backed out go to the next step.
3. Remove the three 6mm and two 5mm allen head cap screws. Coat threads of allen head screws removed with LOCTITE® THREADLOCKER BLUE 242® or equivalent, reinstall allen head cap screws and tighten.
4. Verify the handle arm pivot set screw is tight (reference Informative Bulletin IF - 001) for instructions.
5. Grip the control head handle and move side to side to see if any movement of the handle arm assembly occurs without turning the handle arm assembly. If movement occurs go to the next step.

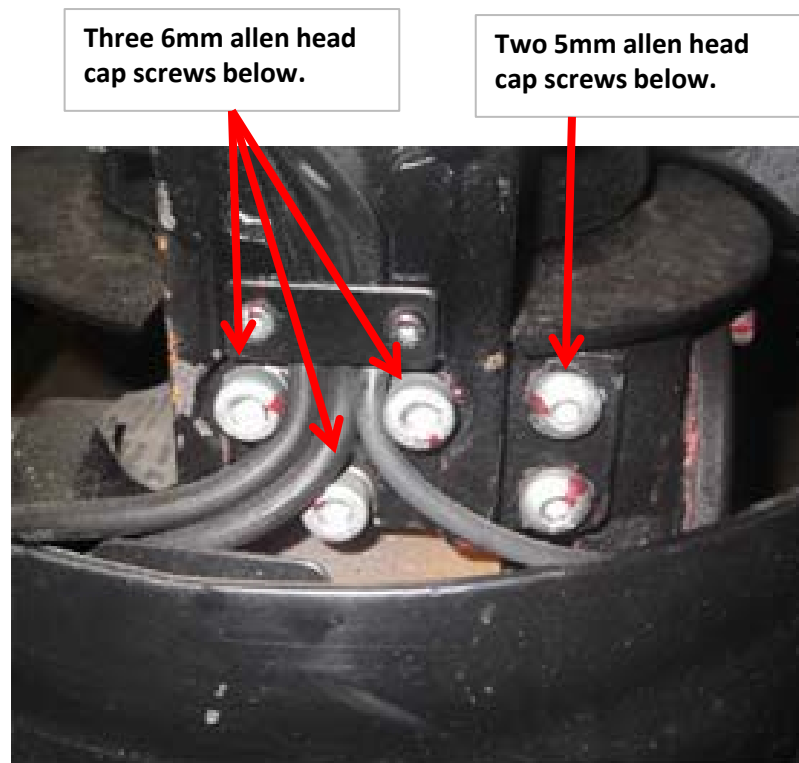
Joint Bracket located behind top cover at the bottom of the handle arm assembly. This bracket bolts into the back of the

6. Secure the handle arm (item 13) in the upright position.
7. Remove gas return cylinder retaining bolt (item 1).
8. Pull downward on the gas return cylinder (item 8) to free it from its seat inside the steering arm.
9. Release handle arm and lay flat on working surface.
10. Remove 3mm handle arm set screw (reference Informative Bulletin IF - 001) noting the position of the handle pivot pin is in the horizontal position (item 9) and remove the handle pivot pin.
11. Remove handle pivot bushings (item 10) and replace with part number 0000-000677-00 quantity (2)
12. Follow reverse procedures for installation of removed components.

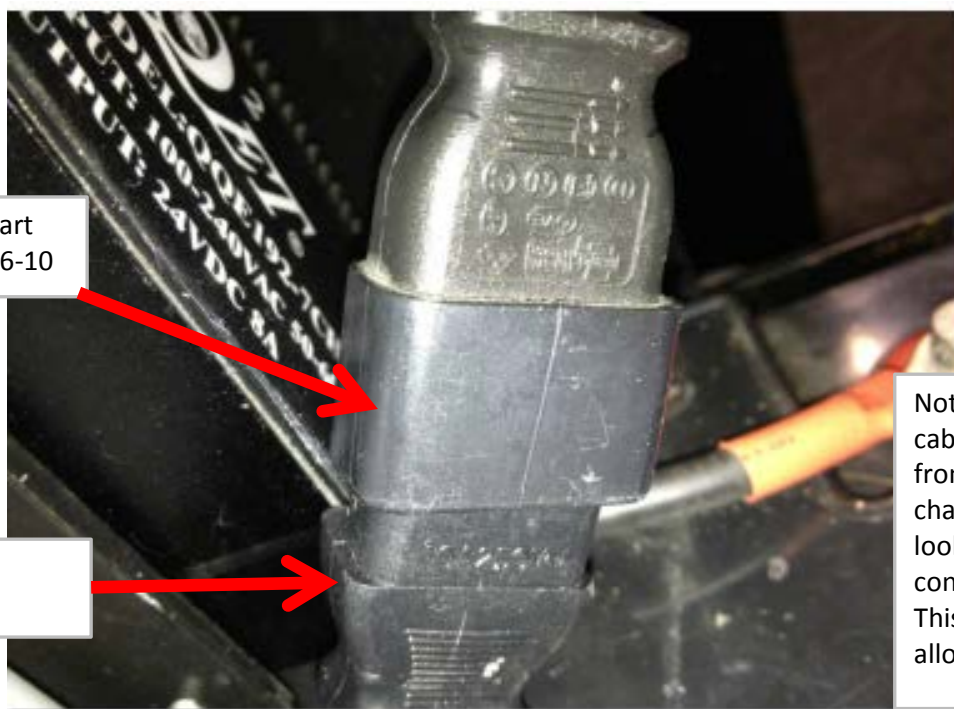
Excessive or continued pulling on the coiled charger cable will cause the coiled charger cable to separate from the stationary battery charger cable receptacle.

coiled battery cable part  
number 1115-500006-10

Stationary battery  
charger receptacle.

1. Remove top cover referencing QT – 003 Quick Tip Bulletin on Emergency Stop Switch Red Knob Removal.
2. Once the cover is removed look for the stationary charger and coiled charger cable plug, this will be located inside the cover on the lower right side of the hydraulic tank.
3. Push the coiled charger cable plug into the stationary charger receptacle and verify it is secure. There should be no spacing between the coiled charger cable plug and stationary charger receptacle if connected properly.

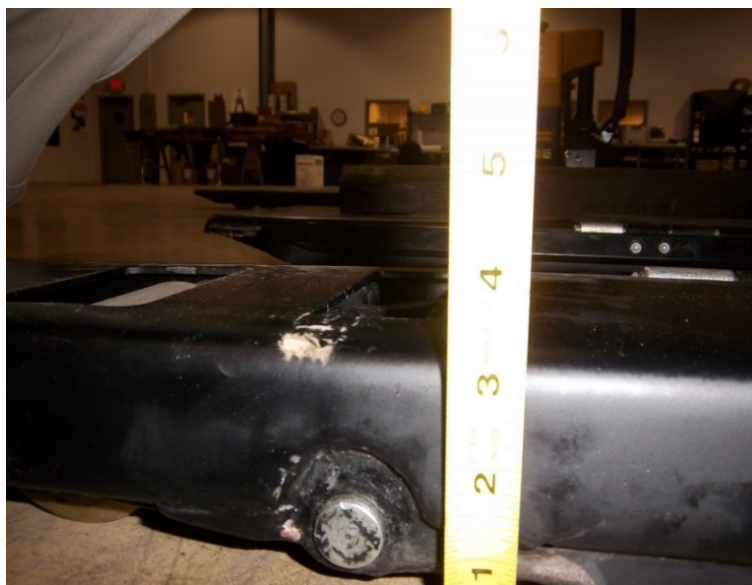
Verify measurement of fork height buy measuring from the floor to the top of the fork, this should be 3".

Minimum Clearance = 4mm or 0.16"

Maximum Clearance = 10mm or 0.39"

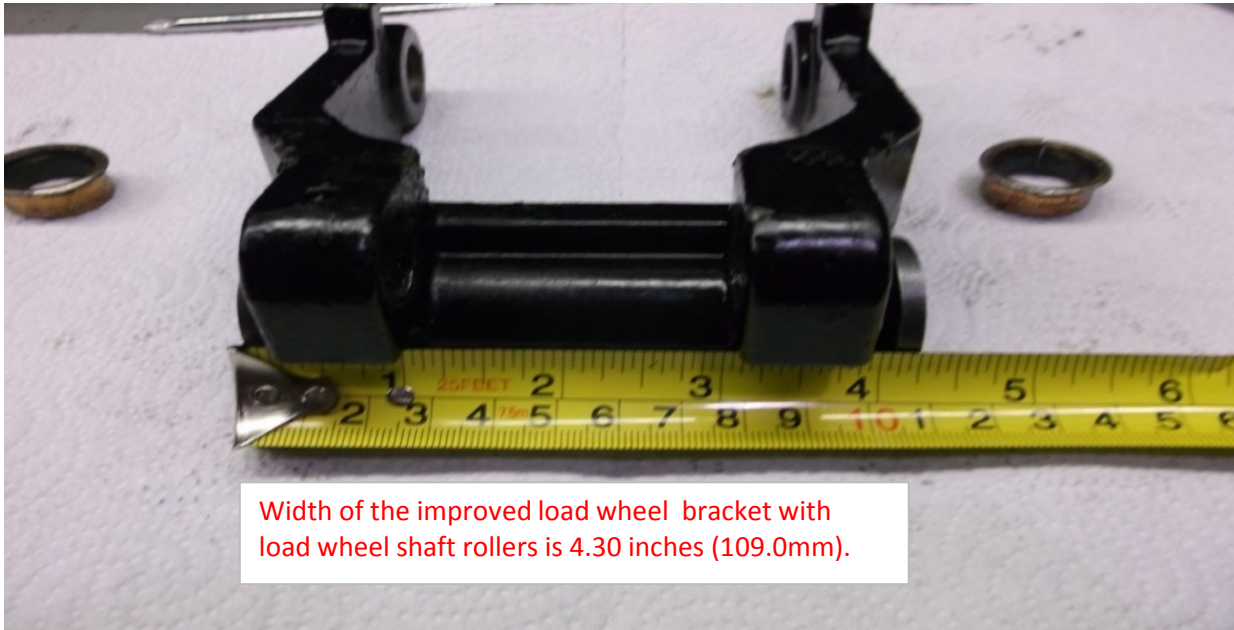
As you can see from the photo below, the overall width has been reduced without a reduction in strength. Width of the improved load wheel bracket is 3.81 inches (97.0mm). With the addition of the two load wheel shaft rollers, the overall width has not changed from the original load wheel bracket width of 4.30 inches (109.0mm).

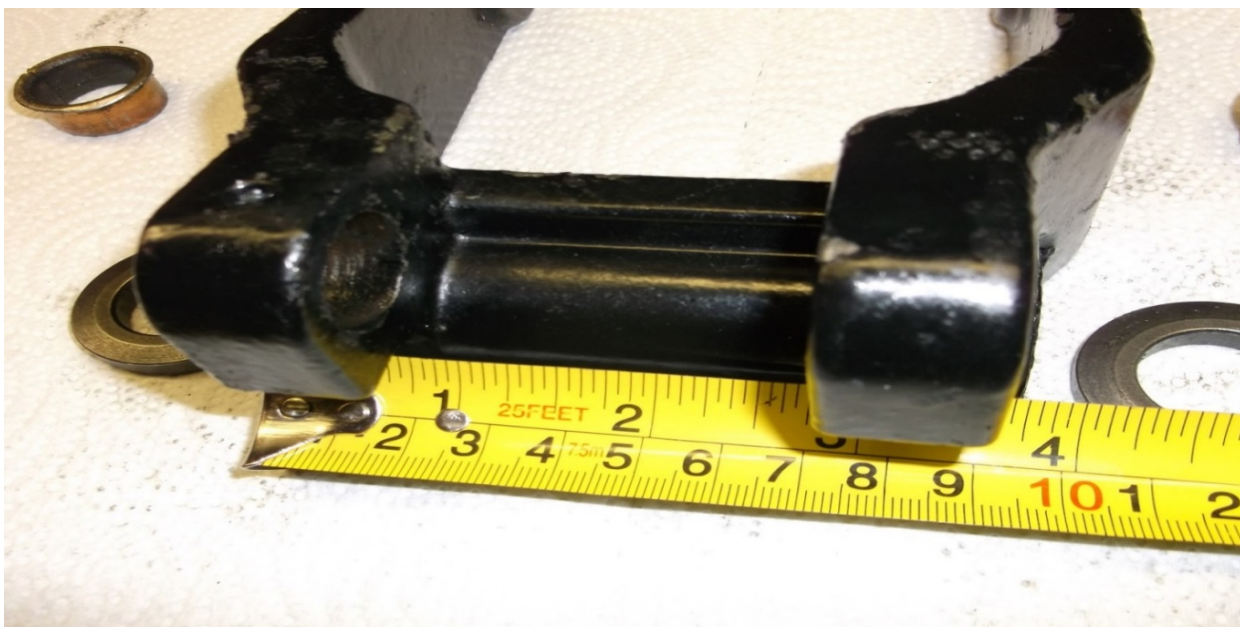
Below photo references improved load wheel bracket width without the load bracket shaft rollers included in the total width. Width of the improved load wheel bracket is 3.81 inches (97.0 mm)

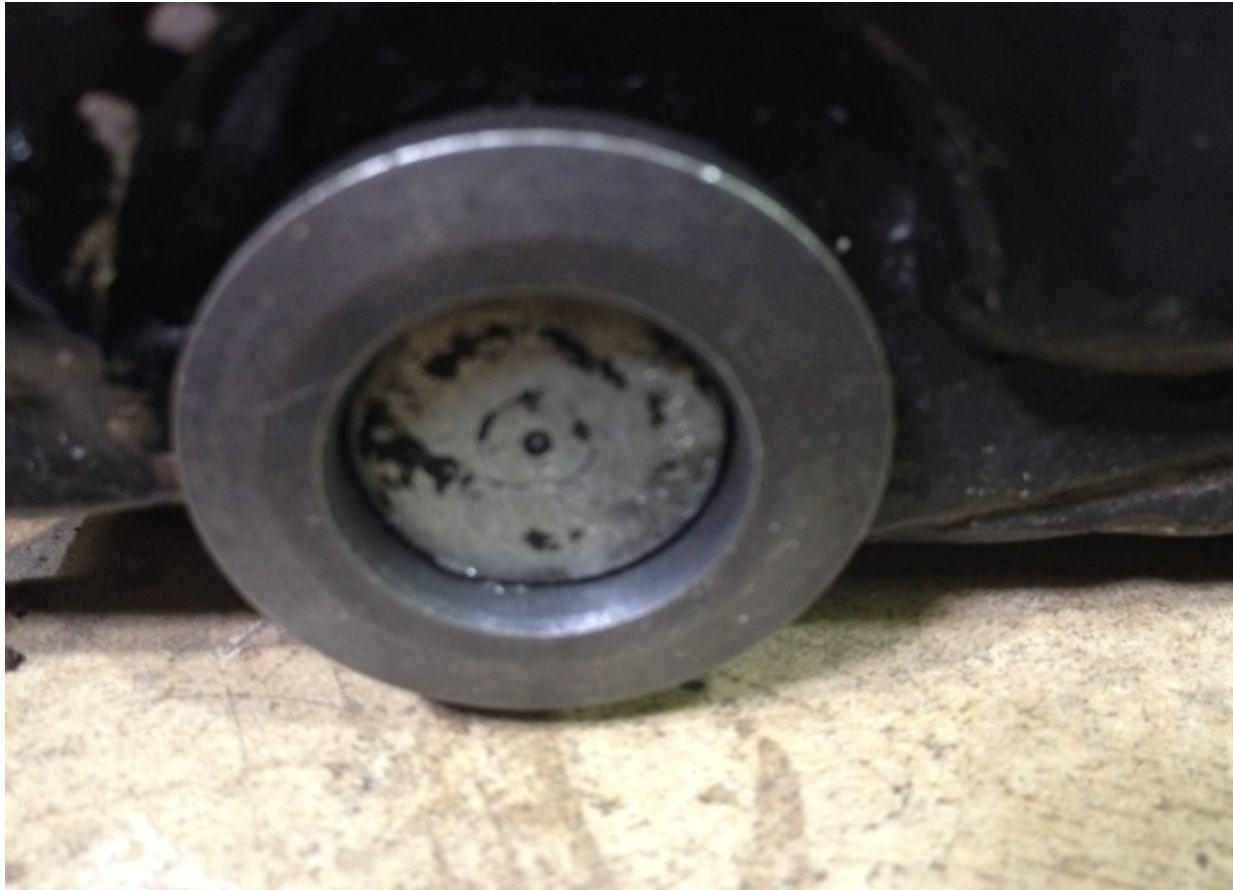
The above photo is of the load wheel shaft roller mounted externally. Minimum clearance from the bottom of the roller to the top of the floor is (2.3 mm).

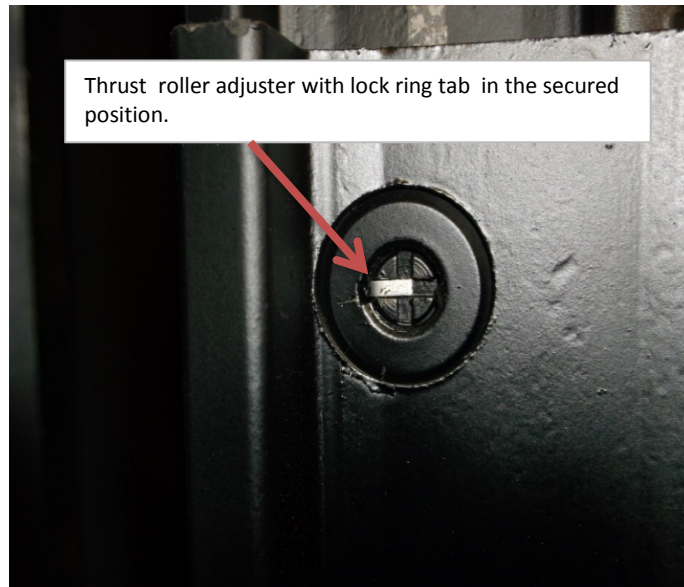
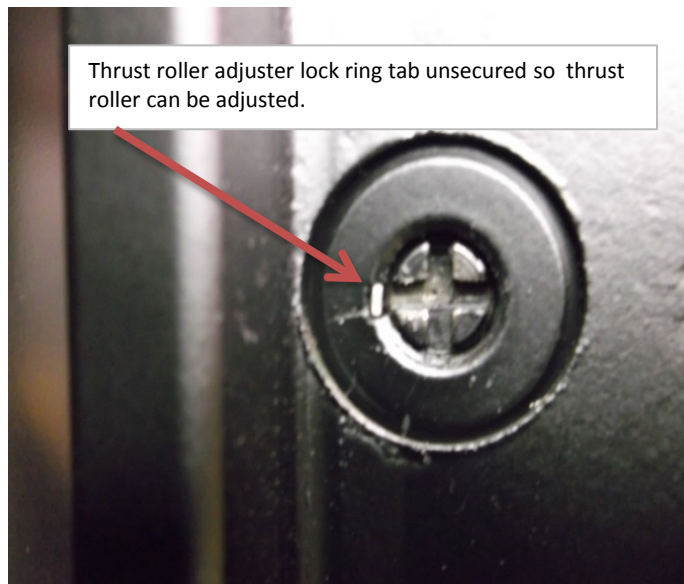
## Side Thrust Roller Locking Ring Location

Primary cause of this complaint is over lubricating of the thrust roller with standard bearing or non Moly-Lube grease This will eventually cause the side thrust rollers to wear off the paint and gouge the inner rail causing the mast to squeal when raising or lowering. Adding non Moly -Lube grease will catch any paint particles and imbed them in the side thrust roller causing the roller to slide in the inner channel instead of rolling.

Once the side thrust roller locking ring tab has been unsecured by carefully prying it back you can start the side thrust roller adjustment. Prior to making the adjustment inspect the roller to be sure it is not bent or damaged, grab the roller and see if there is any vertical or horizontal movement, if there is the roller must be replaced. Adjust the side thrust roller so there is .025 between the inner mast channel and the side thrust

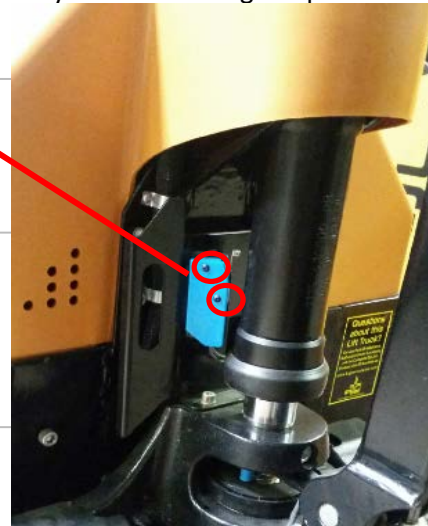
The lift limit micro switch bracket screws are may be overtightened causing the lift limit switch to not engage when lifting or lowering. The M3 X 20 screws when ovetightened will depress the micro switch bracket on the side walls of the micro switch causing the lift limit switch to act as defective. Troubleshooting of the lift limit will confirm it as being defective.

When pre-delivering the E30 and/or EZ30 loosen each lift limit switch bracket screw and remove. Coat threads with LOCTITE ® THREADLOCKER BLUE 242 and reinstall. Torque spec for tightening the M3 X 20 is 0.464 FT-LB or snug down until tight. Overtightening may crack the lift limit micro switch bracket or cause the lift limit switch not to function.

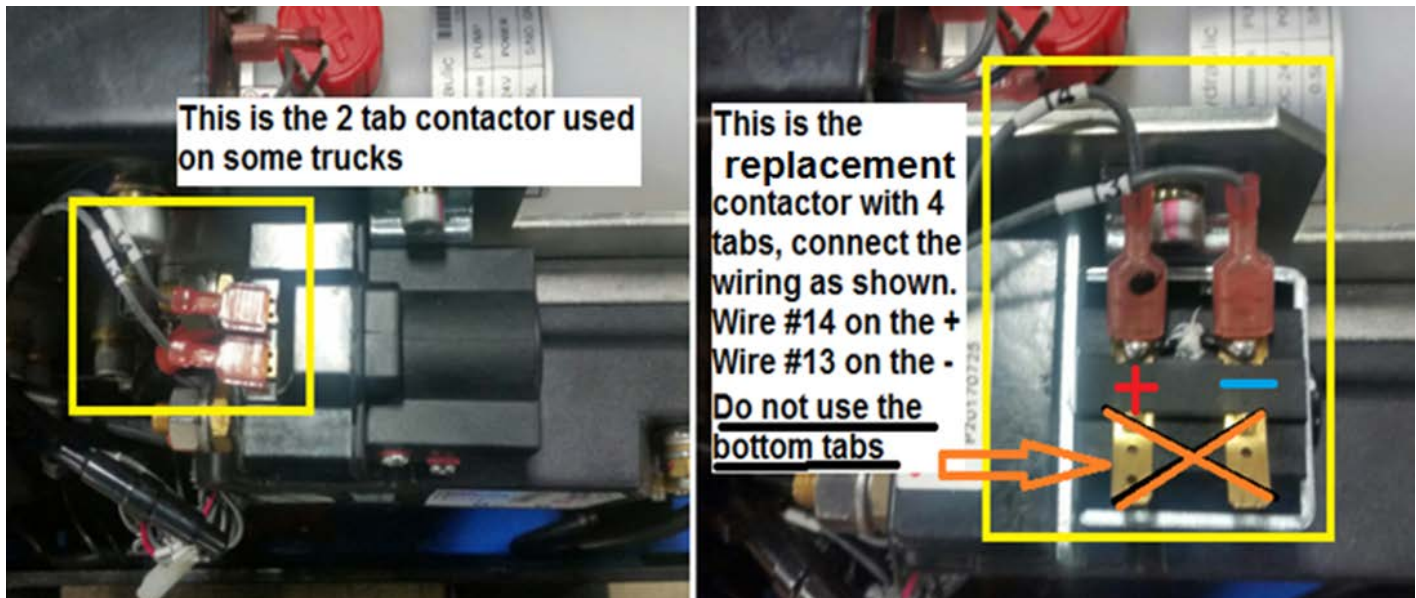
Figure 1

Cause: Replacement part not wired properly
