DETROIT DIESEL

MBE EGR Technician's Guide

The information in this document is accurate as of **May 2005** and is subject to change without notice. This manual is to be used in conjunction with the *MBE Electronic Controls Troubleshooting Guide*, 6SE422.

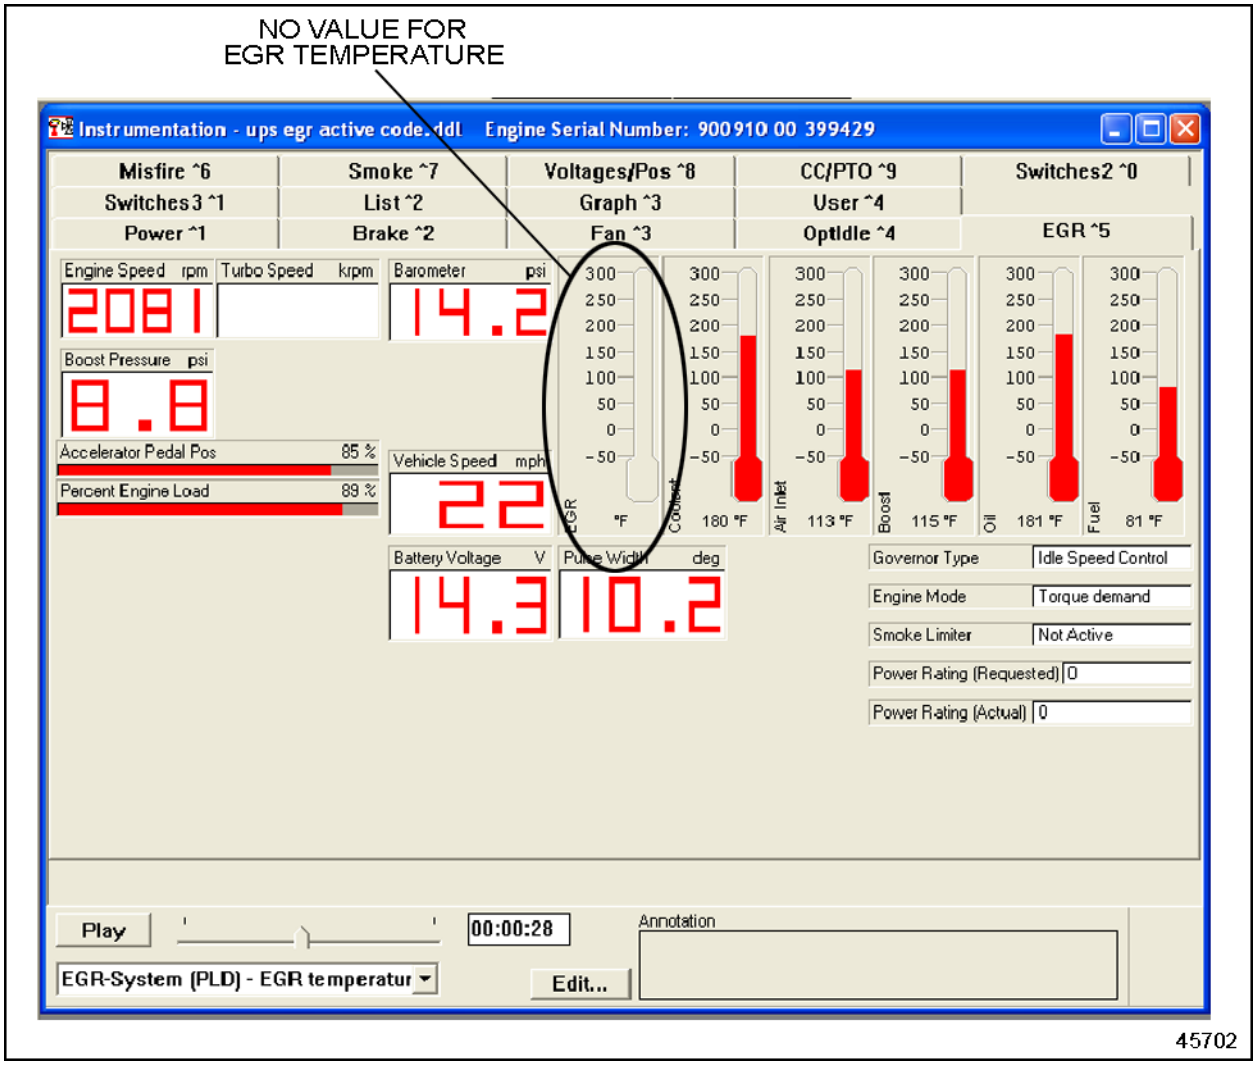
Figure 7-7 MBE 900 Engine Running with No EGR Temperature Reading — Diagnostic Instrumentation Window

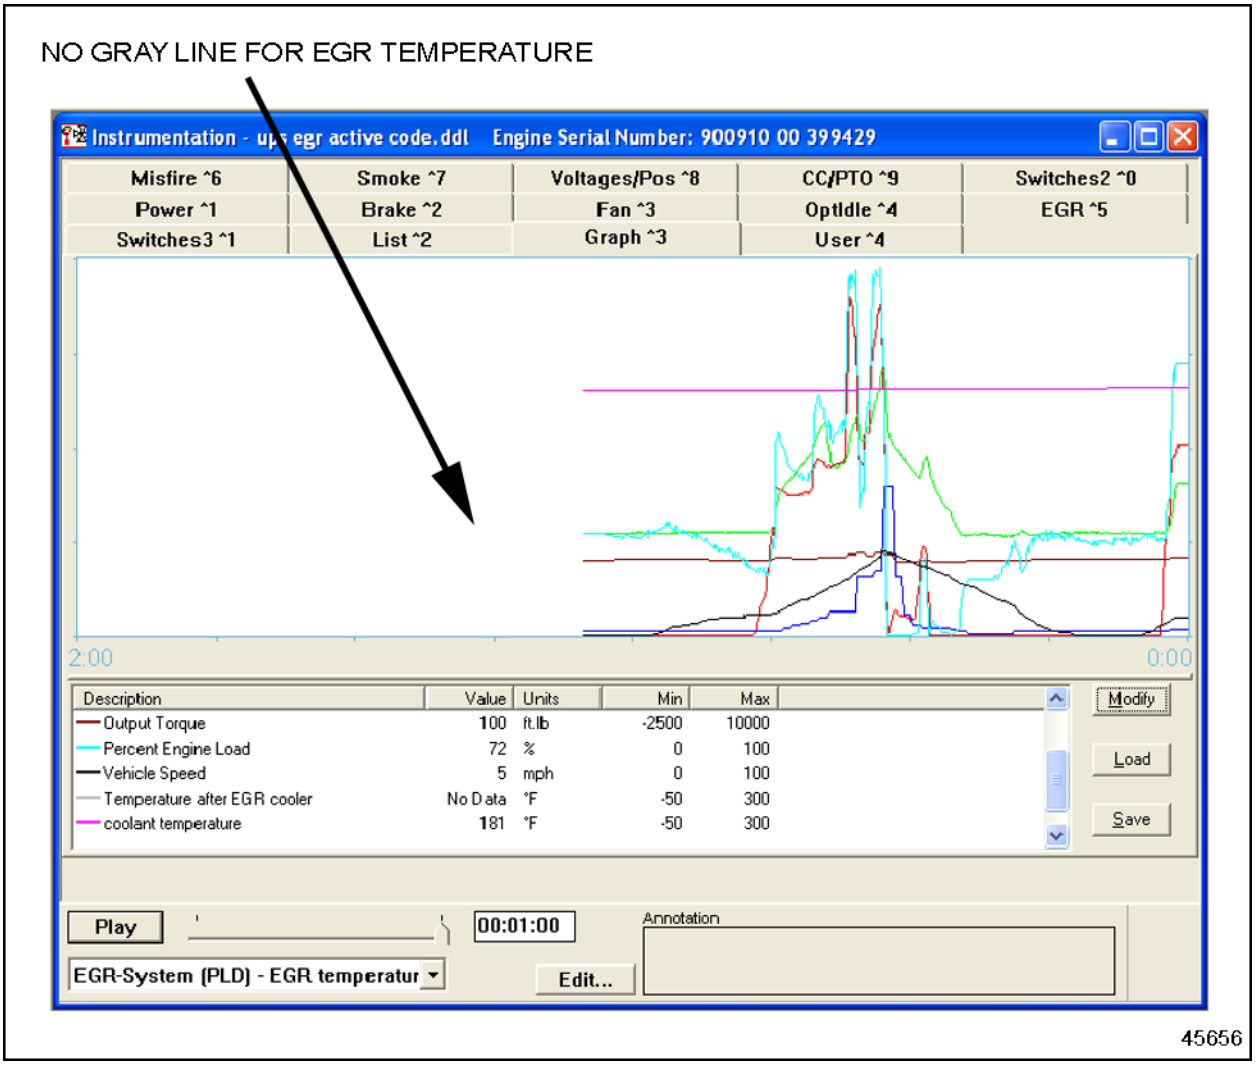
Figure 7-8 MBE 900 Engine Running with No EGR Temperature Reading — Graph Window

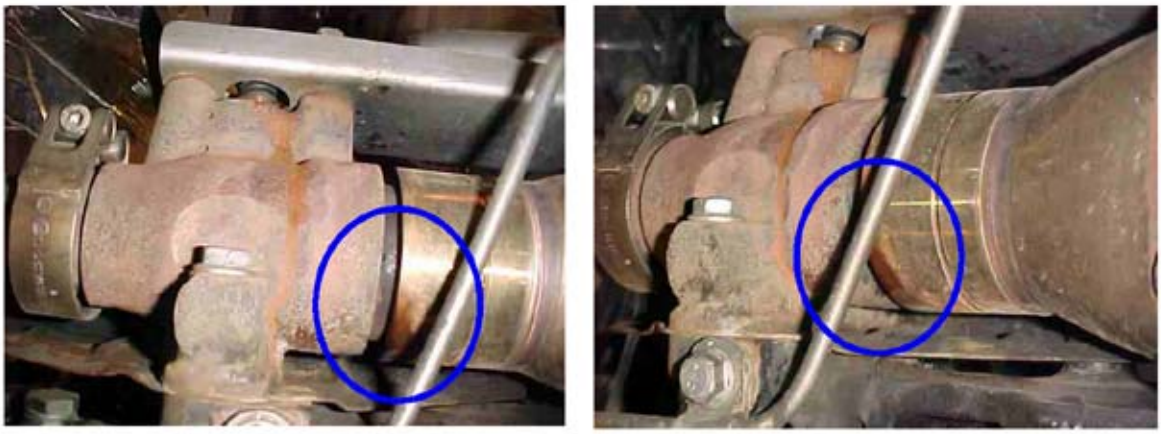
Figure 1 – traces of water/coolant around the shutoff valve

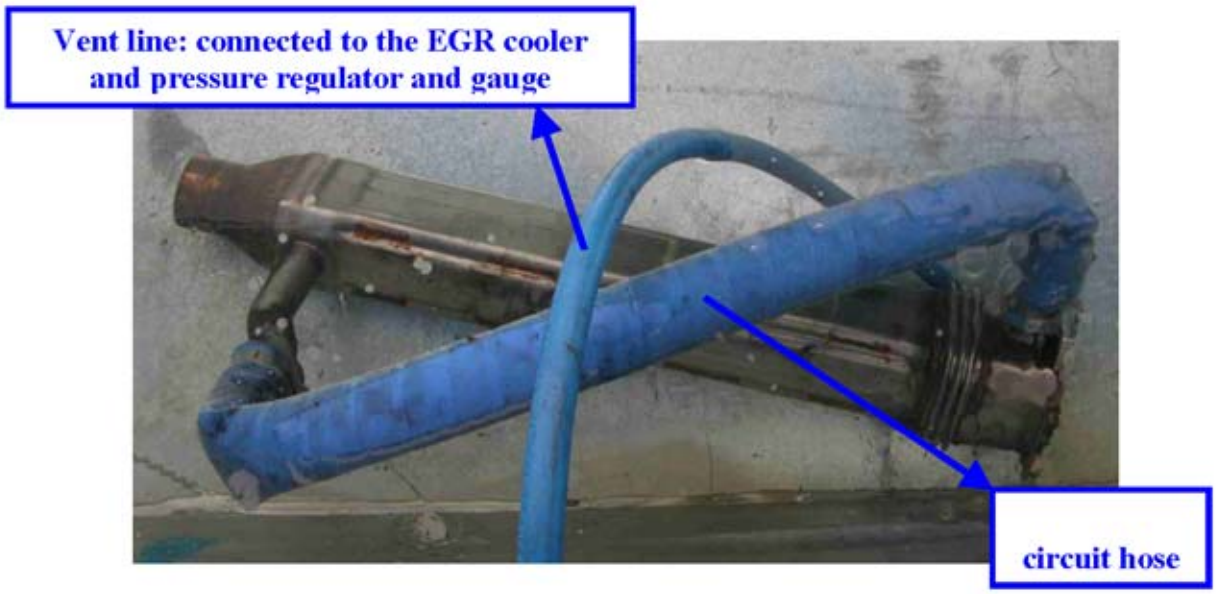
Figure 2 - EGR cooler ports: short-circuited

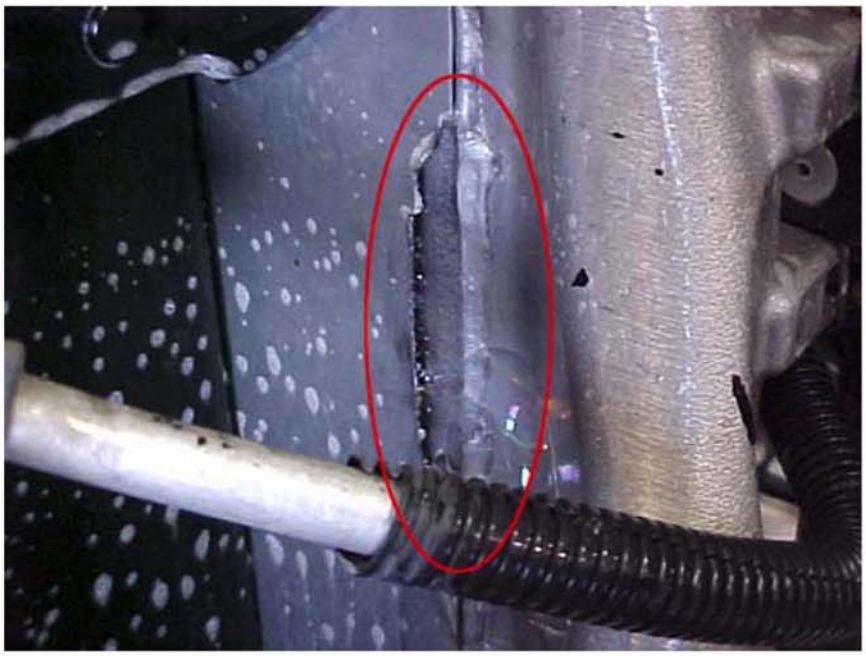
Figure 1 **Cracked Charge Air Cooler Housing**

NOTE:
Refer to Service Information Letter 05 **TS**-01 for service information on cracked charge air coolers. See Figure C-16 and Figure C-17.

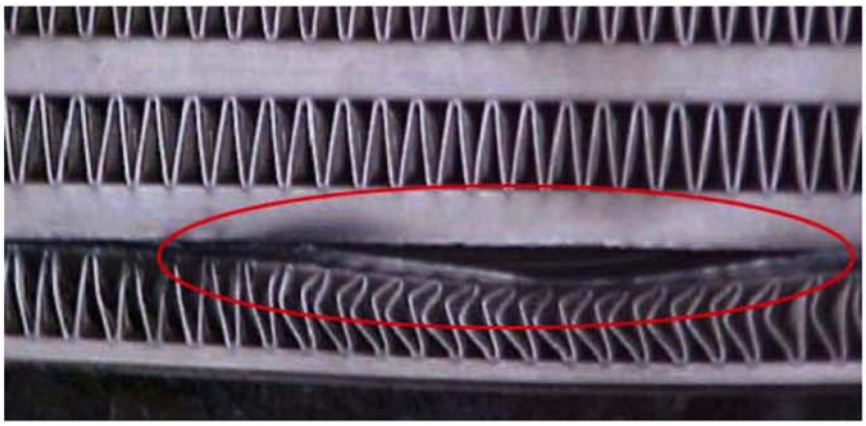
Figure 2 **Failed Charge Air Cooler Core**
