**BIG LIFT LLC** LIFT TRUCK SALES AND SERVICE

## Service Bulletins

| Quick Tip Bulletin | Date: | March 3, 2012 | Bulletin Number: | QT - 001 |

| Model: | E30 – EZ30 | Description: | Troubleshooting Intermittent Shutdown |

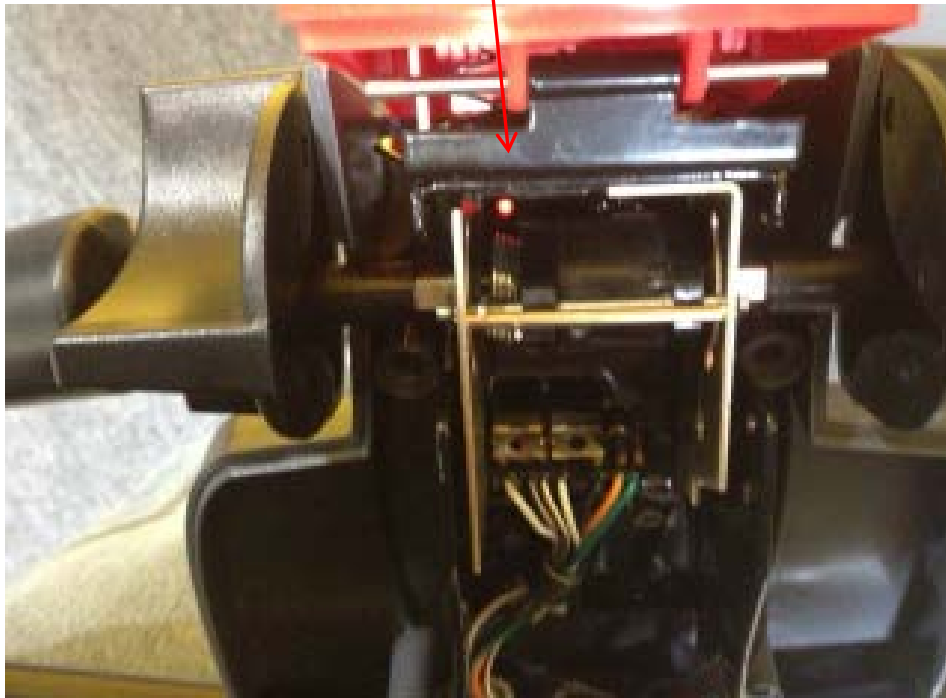
**Control Head Power LED Indicator**

1. Remove (4) 4mm allen head screws from the back of the control head cover.
2. With key switch on verify Red LED is lit, the LED is located behind the accelerator potentiometer on the upper left side of

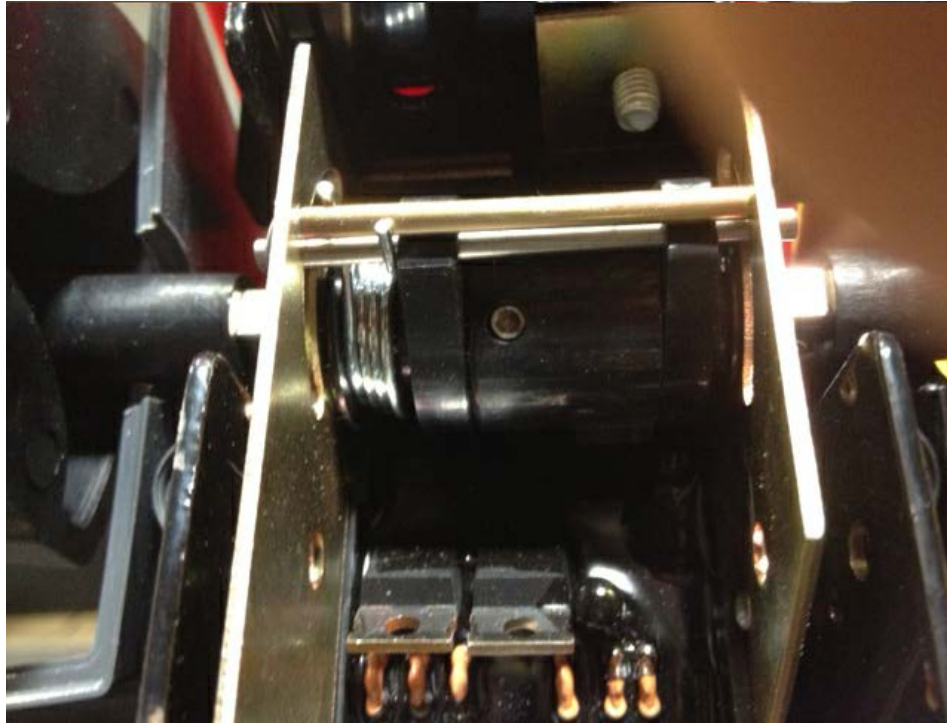
3. Operate thumb buttons both forward / reverse and visually watch to see if there is any play between the potentiometer and thumb buttons when moving, the electric pallet jack should operate immediately upon moving the thumb buttons, if no movement proceed to step (4).
4. Check the accelerator set screw for tightness, if loose remove set screw and coat threads with LOCTITE® THREADLOCKER BLUE 242® or equivalent and reinstall. If the set screw backed out you may need to reset the accelerator control.
5. Hook up the Curtis 1311 – 4401 hand held programmer to the Curtis Controller self- diagnostic port.

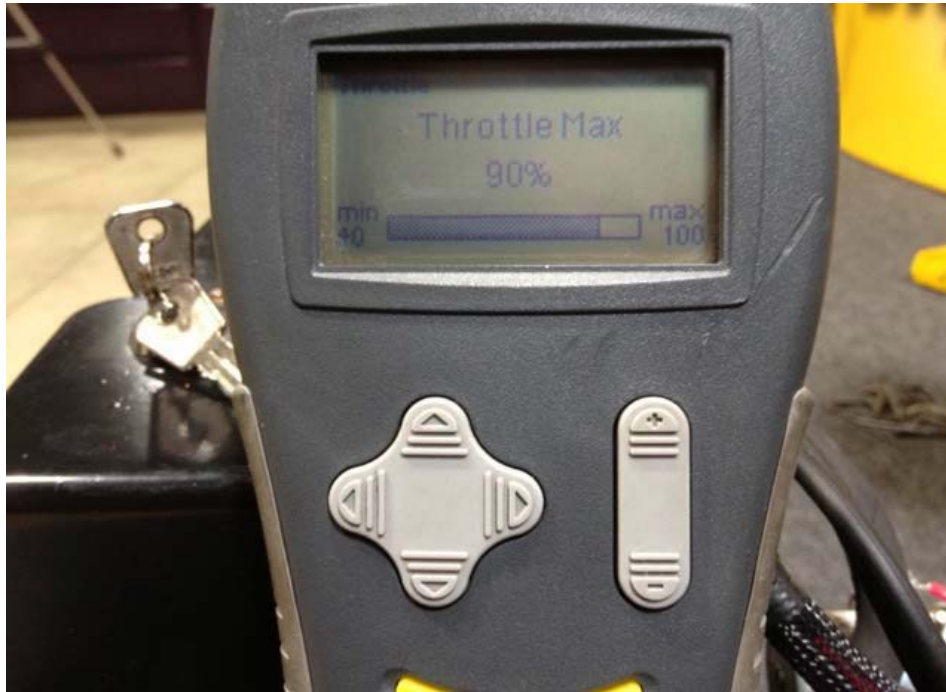
6. From your Curtis main menu scroll down to the throttle menu. Once in the throttle menu, arrow down to throttle max and right arrow this will show you the minimum / maximum parameters for the accelerator as well as the current setting.

7. If your throttle max falls outside of the recommended setting of 90, simply press the (+ / -) on the parameter adjustment button until see the recommended setting on the display. To activate the setting go to the menu navigation key and depress the left arrow, this will bring you back to the throttle menu and save the setting just made.

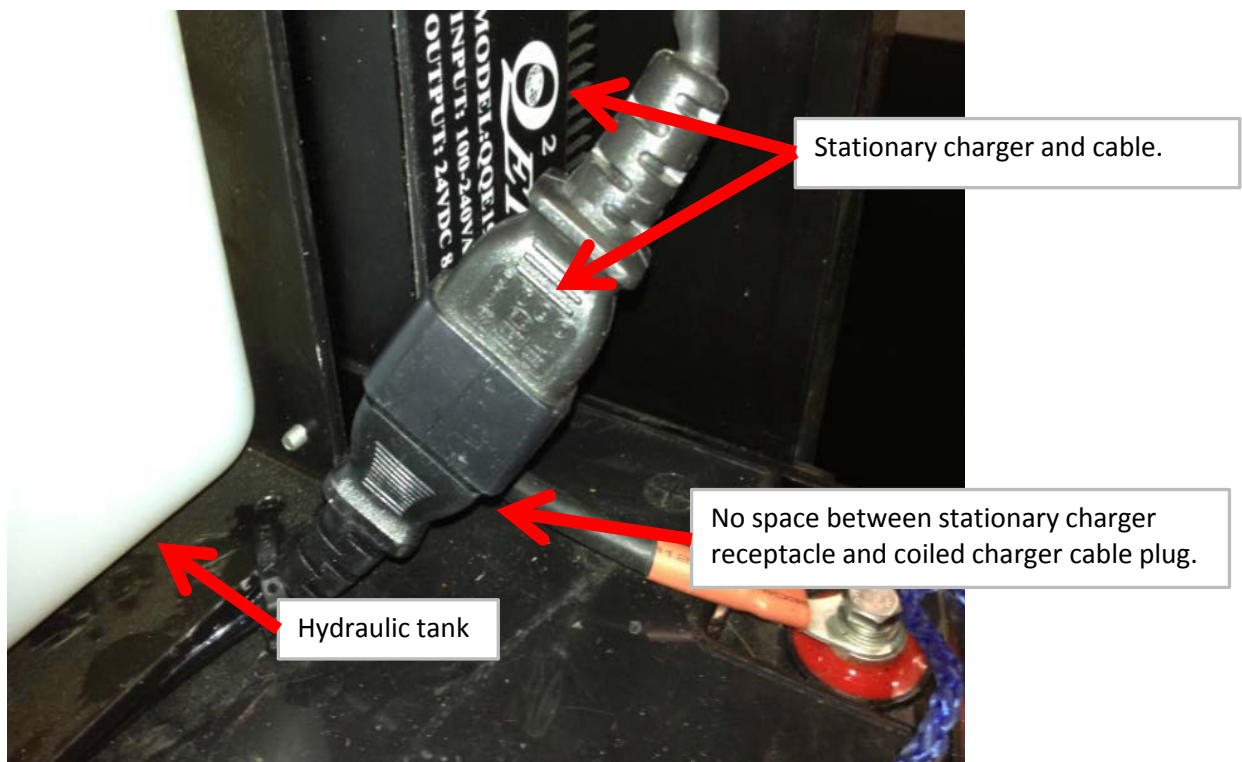
Excessive or continued pulling on the coiled charger cable will cause the coiled charger cable to separate from the stationary battery charger cable receptacle.

1. Remove top cover referencing QT – 003 Quick Tip Bulletin on Emergency Stop Switch Red Knob Removal.
2. Once the cover is removed look for the stationary charger and coiled charger cable plug, this will be located inside the cover on the lower right side of the hydraulic tank.
3. Push the coiled charger cable plug into the stationary charger receptacle and verify it is secure. There should be no spacing between the coiled charger cable plug and stationary charger receptacle if connected properly.

Parts needed for repair, (3) 8inch wire ties.

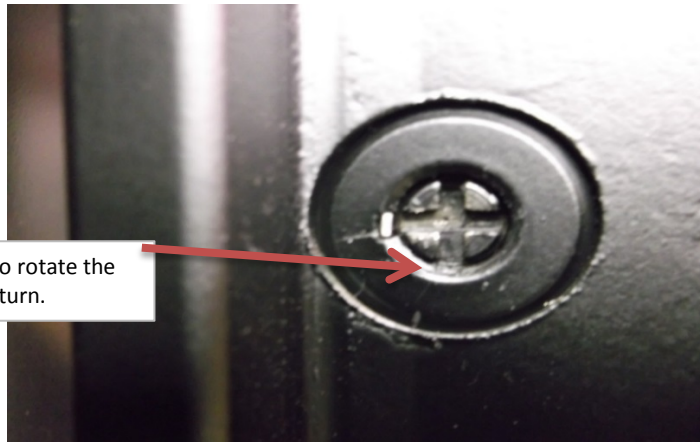
IF-005-2

Primary cause of this complaint is over lubricating of the thrust roller with standard bearing or non Moly-Lube grease This will eventually cause the side thrust rollers to wear off the paint and gouge the inner rail causing the mast to squeal when raising or lowering. Adding non Moly -Lube grease will catch any paint particles and imbed them in the side thrust roller causing the roller to slide in the inner channel instead of rolling.

Using a large screwdriver, the adjustment can be made by turning the side thrust roller either clockwise or counter clockwise.

Next available adjustment will be to rotate the side roller counter clockwise (1/4) turn.

Incremental adjustments are made by rotating the side thrust roller to the next available cross section of the adjuster. The locking tab will stay in its original position.

Once you have made the adjustment bend the locking ring tab back into the cross hairs to secure the side thrust roller. It may take multiple times to fully make this adjustment, be sure not to under adjust the side thrust roller. This will cause unnecessary side to side play in mast. Over adjustment of the side thrust roller will cause the unnecessary scrapping and gouging of the mast.

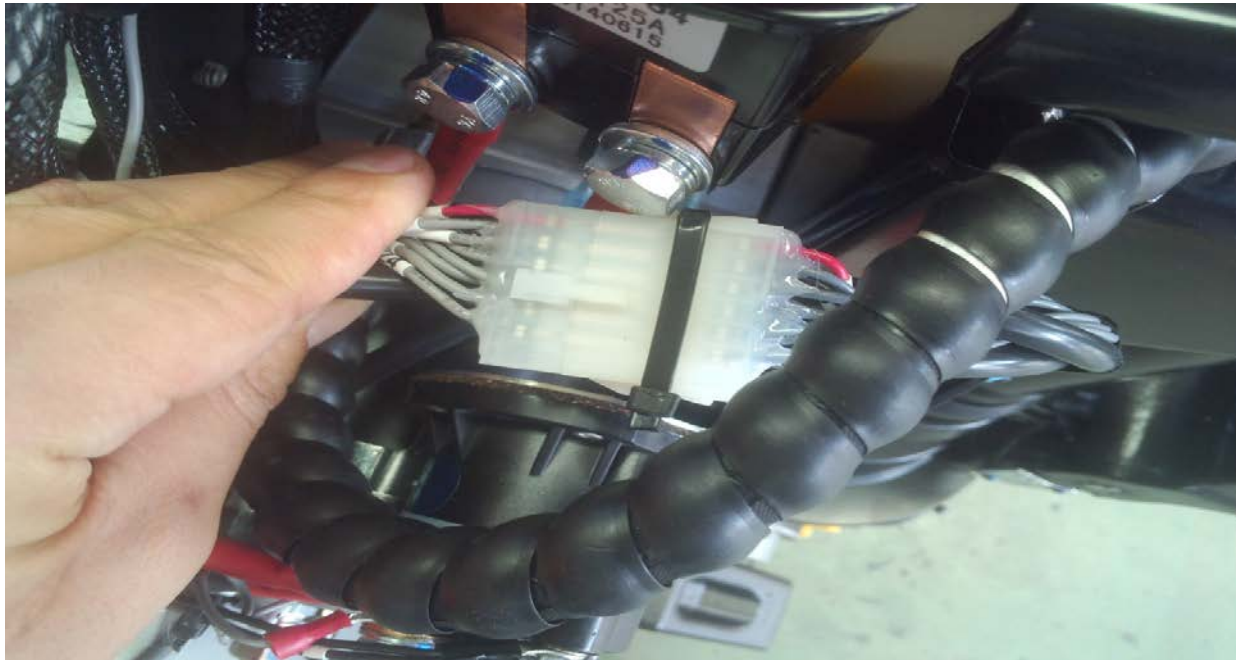
When using the E-30 / EZ-30 and D-40 / EZ-40 in a refrigerated trailer to make deliveries , there have been occurrences when units are removed from the refrigerated trailer in high ambient temperature areas the units will begin to condensate / sweat. This will cause the condensation to drip into the wiring harness connectors and switches causing the unit to intermittently stop until the affected areas dry out.

- 1: The connector between Master Wiring Harness (1115-520001-0B) and Drive Wire Harness (1115-520002-0C)

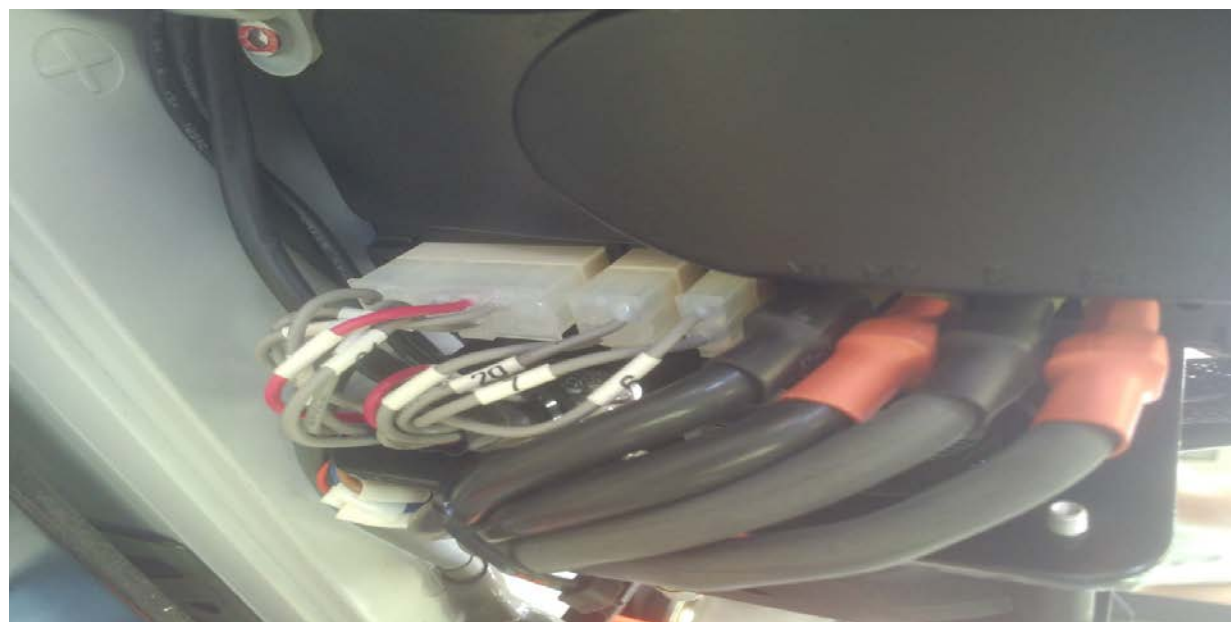
- 2: The connector between Master Wiring Harness (1115-520001-0B) and Controller (1115-510004-0A)

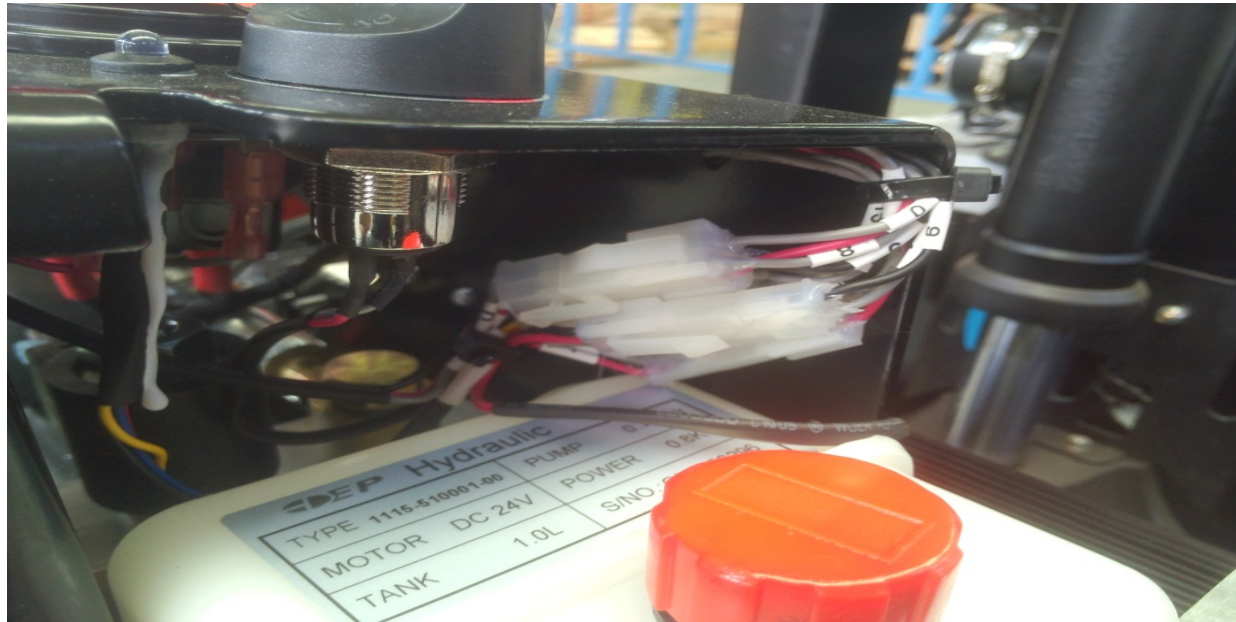
3 : The connector between Master Wiring Harness (1115-520001-0B), key switch (1115-520019-00), indicator assembly (1115-520005-0A) and indicator light on charger (1115-520014-0A)

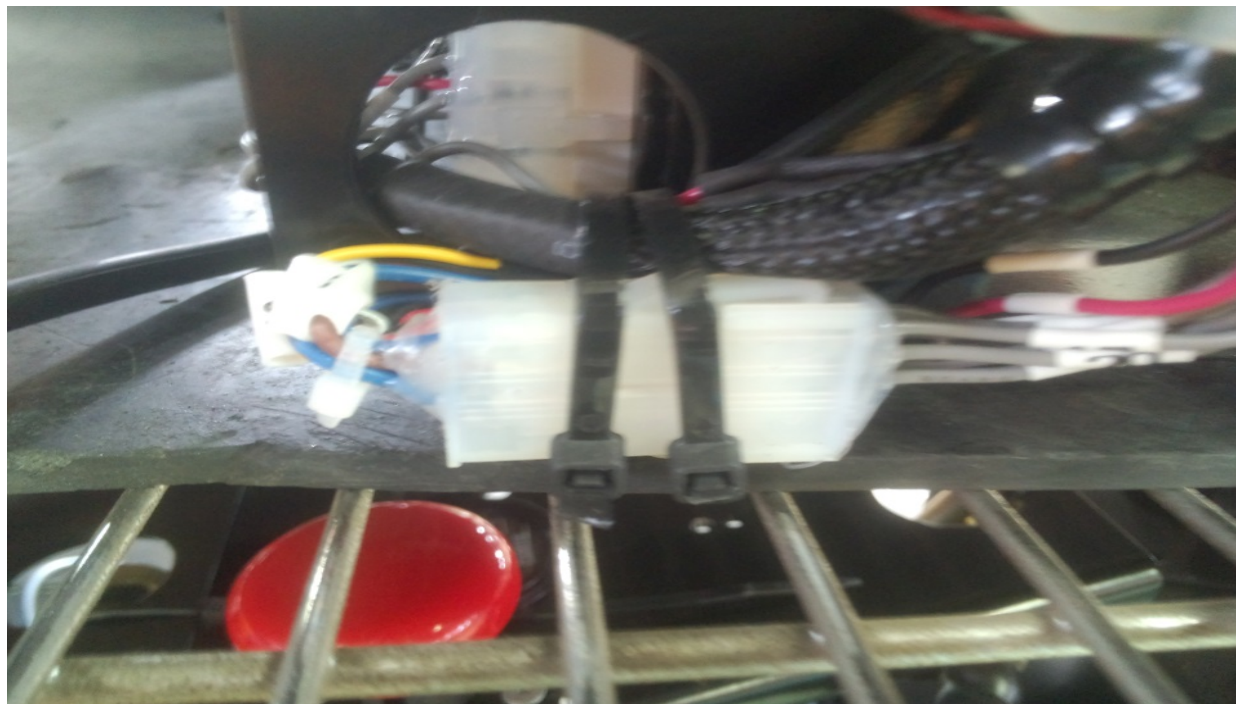
4: The connector between Master Wiring Harness (1115-520001-0B) and charger (1115-520014-0A)

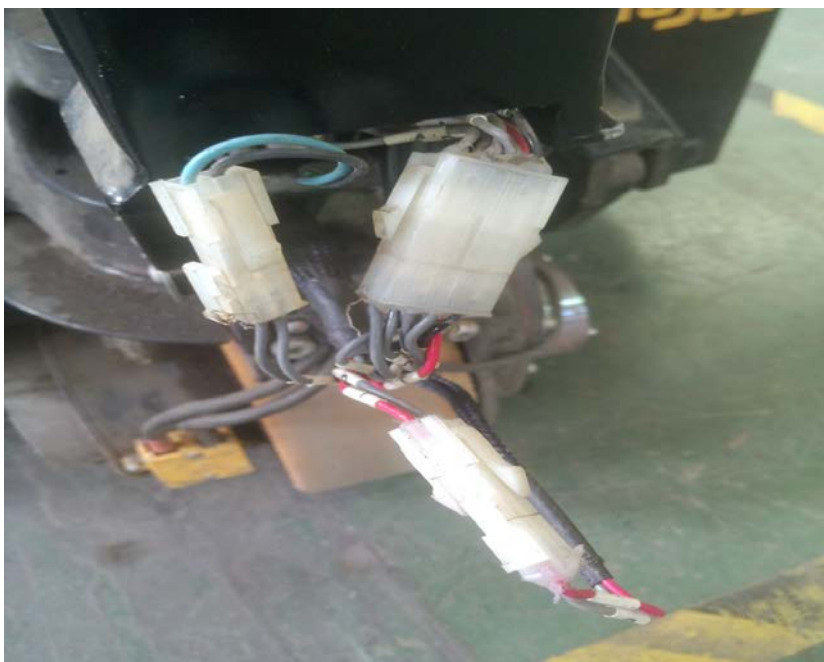
5: The connector between Drive Wire Harness (1115-520002-0C) and Wire Harness (1115-520010-0A)

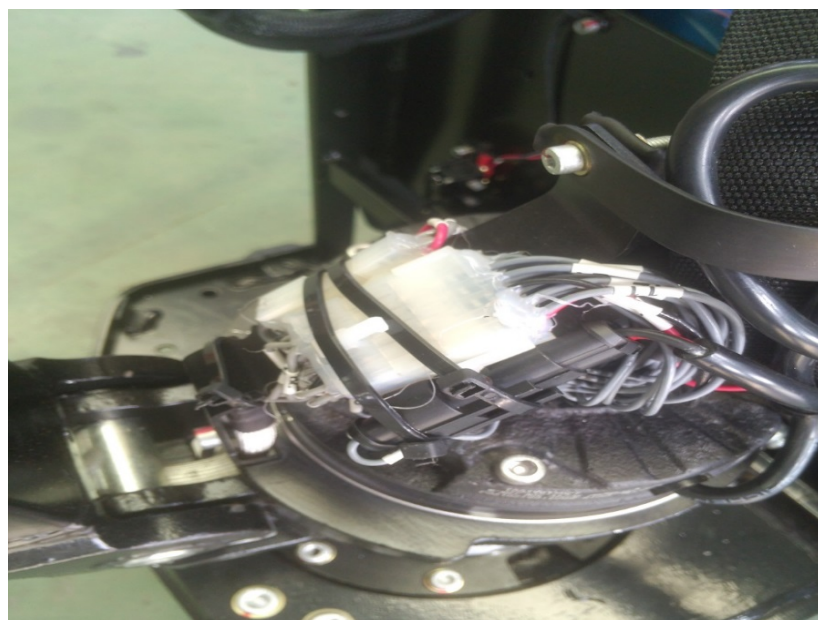
1: The connector between Master Wire Harness (1118-520001-00) and Wire Harness Assembly (1118-520003-00)

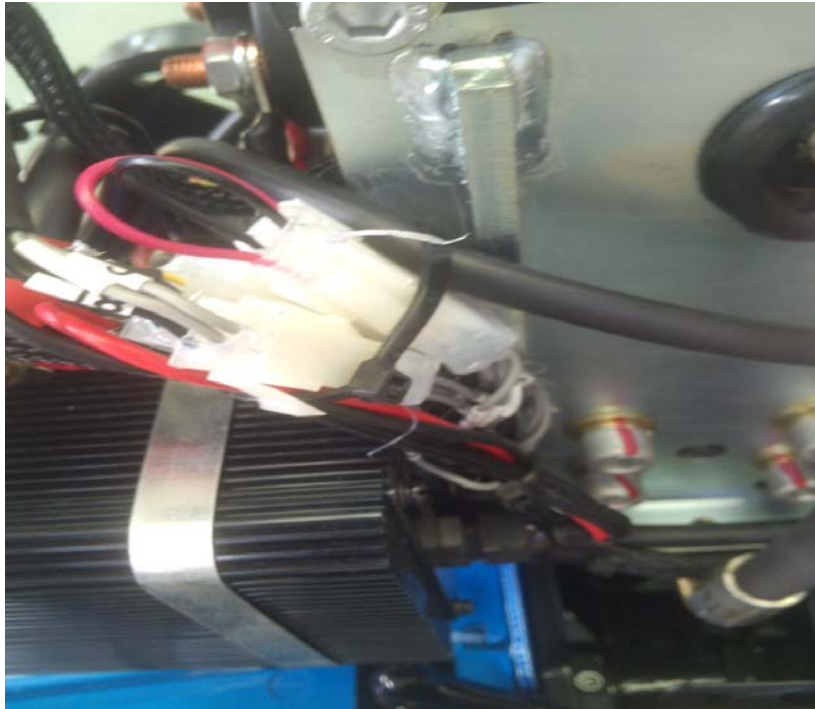
2: The connector between Master Wire Harness (1118-520001-00) and charger (1118-560006-00)

To add the Silicon Di-Electric Grease for MOLEX non-waterproof connector, you need to add the grease to both ends. If the wire end of the connector has already been sealed you only need to add the Silicon Di-Electric Grease to the unsealed

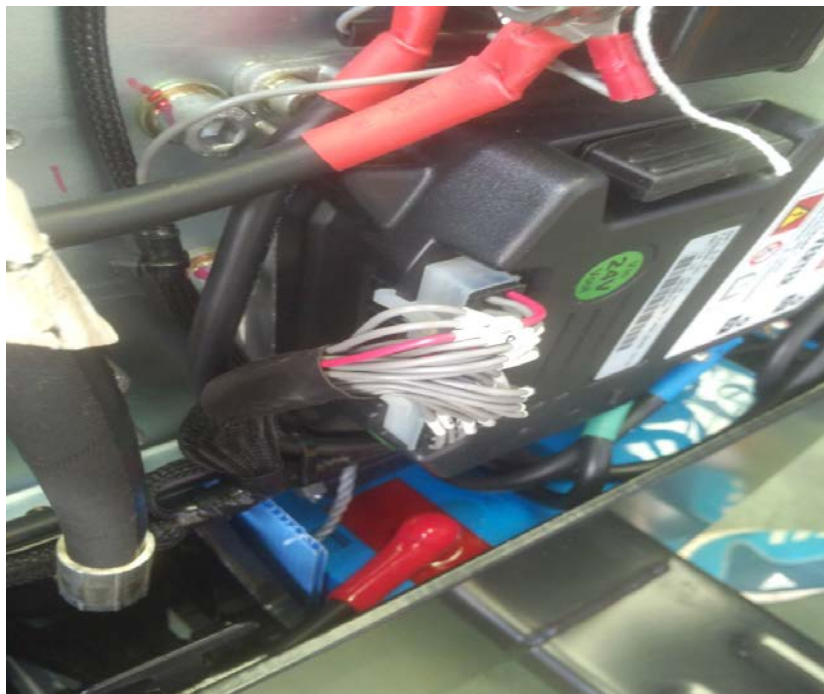
3: The connector between Master Wire Harness (1118-520001-00) and controller (1120-500004-00)

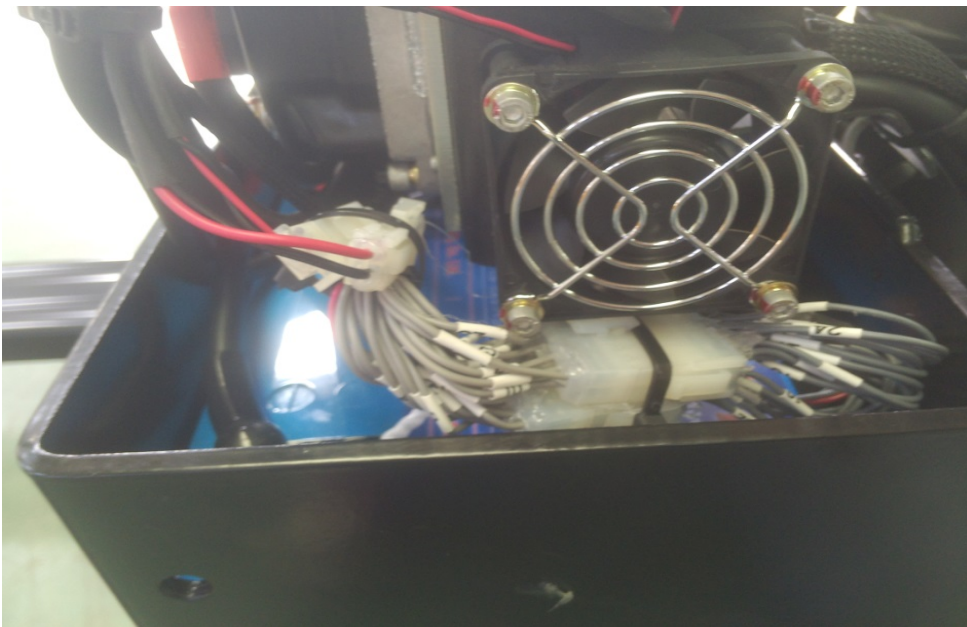
4: The connector between Master Wire Harness (1118-520001-00) and Switching Wire Harness (1118-520002-00)

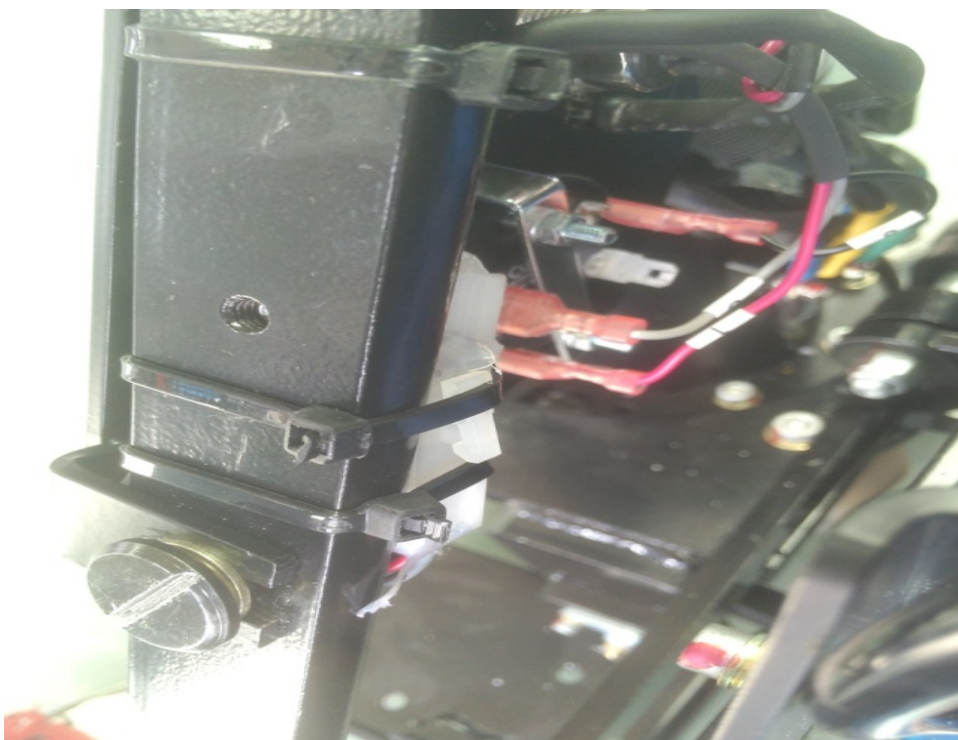
5 : The connector between Switching Wire Harness (1118-520002-00), indicator assembly (1115-520005-0A) and key switch (1115-520019-00)

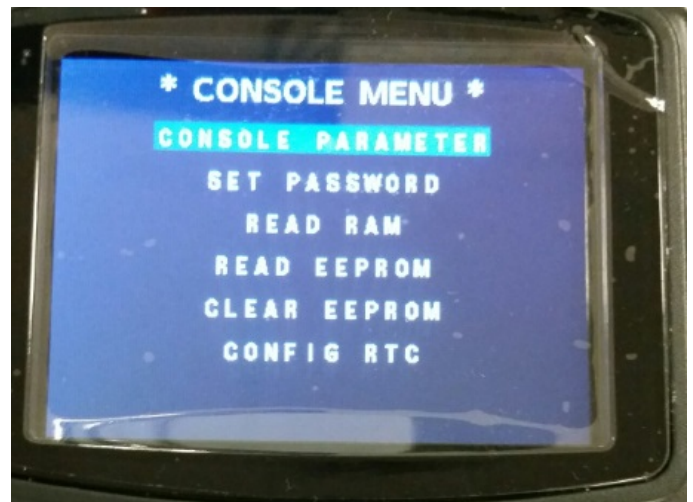
**Cause:** IN THE MENU CONSOLE SCREEN UNDER THE CONSOLE PARAMETERS, THE SERIAL BAUDE RATE IS NOT SET TO 9600 bps

TURN ON THE HANDSET , GO TO  
CONSOLE MENU THE PRESS THE  
OK BUTTON
